The MINERvA Operations Report

All Experimenters Meeting

Howard Budd, University of Rochester
Aug 6, 2012

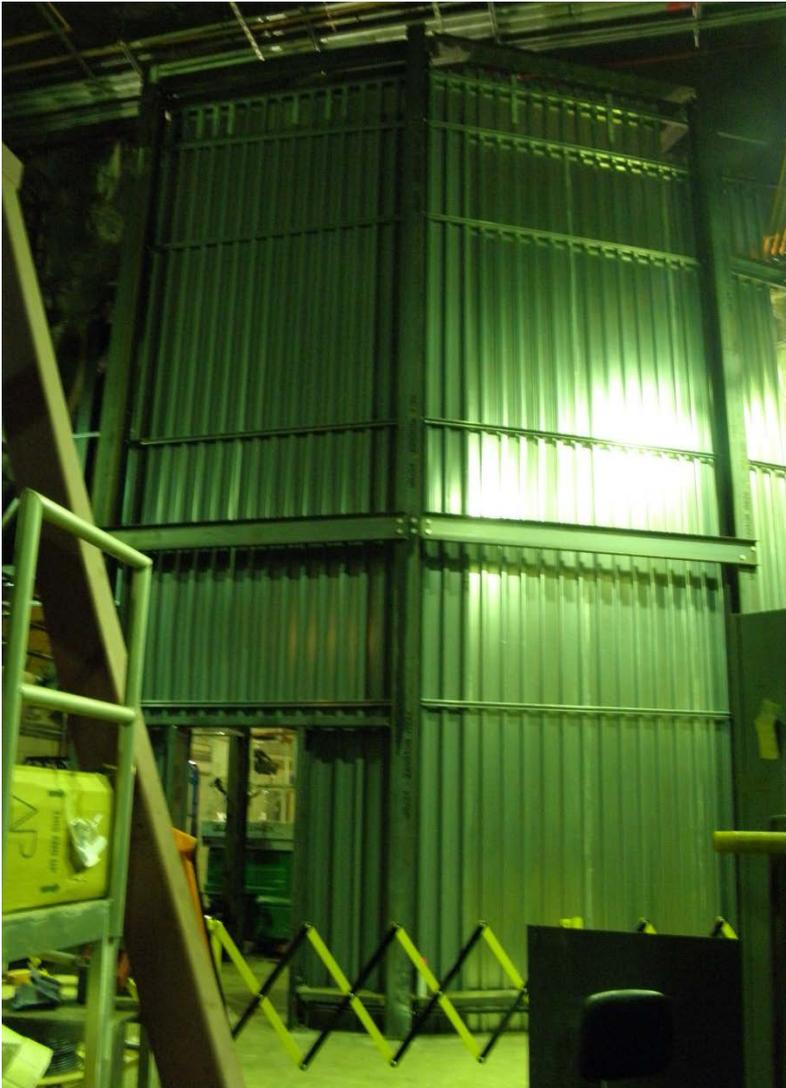
Divider Wall in front of MINERvA & MINOS

- The wall between the construction area and the MINERvA and MINOS detector is being constructed.
- Should be finished by the end of the week

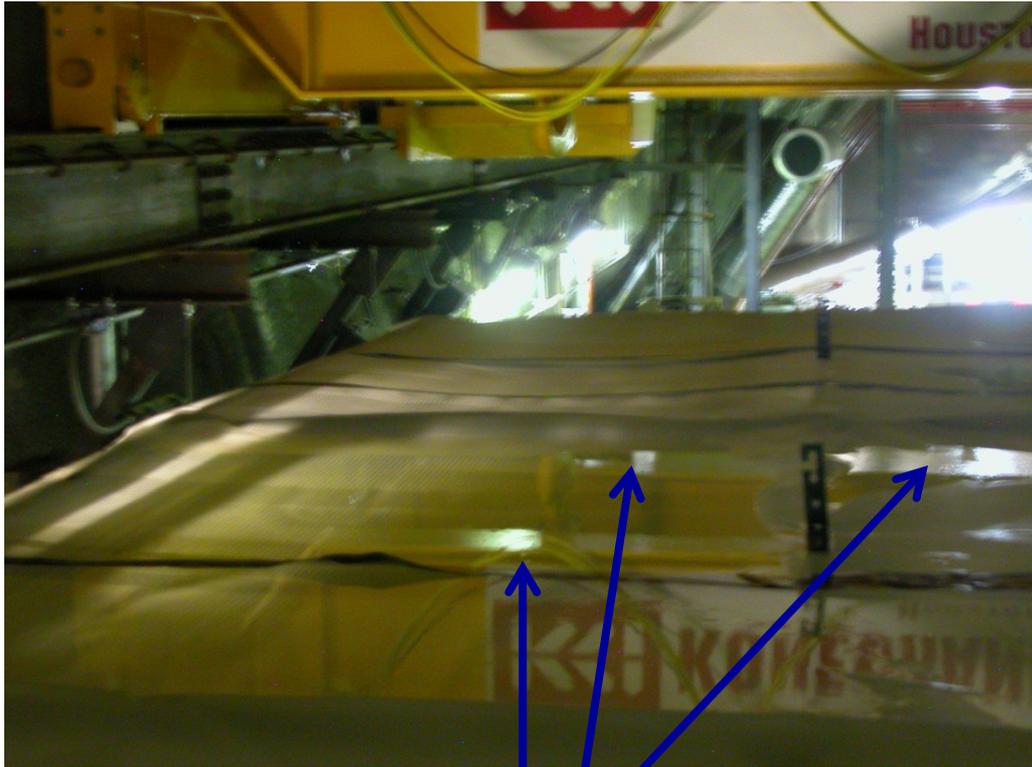
Drip Pans Overflowed Last Week

Water

- Drip pans overflowed onto MINERvA roof
- Roof prevented any water from getting on the detector or racks.
- 65 gal was drained from the roof using a shop vac
- Need to clean out drip pans more often
- Thank PPD for addressing this situation
- Looking into replacing roof with something else

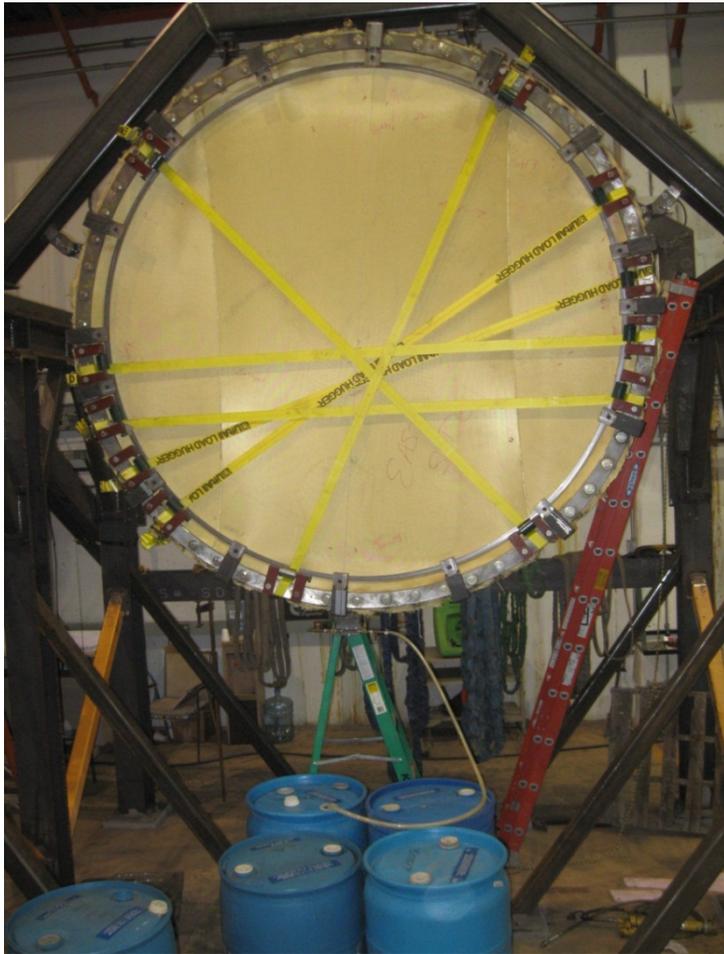
Refilling and Draining the Water Target

- In filling and draining the water target we used a flow meter.
 - Put 192.6 gal in the water target.
 - Drained 148.7 gallons, 44 gal difference
- Expect 175 gal, Bob Wands calculation
- Refilled target, The barrels were weighted before and after the water was put into the target. No flow meter was used
 - Put in 172.5 gal
- We drained the target
 - Put a drum on the scale and wrote down the weight of the drum before putting water in the drum and after
 - 171.5 gal, 0.6% difference which is fine
