The MINERvA Operations Report

All Experimenters Meeting

Howard Budd, University of Rochester
Jun 4, 2012

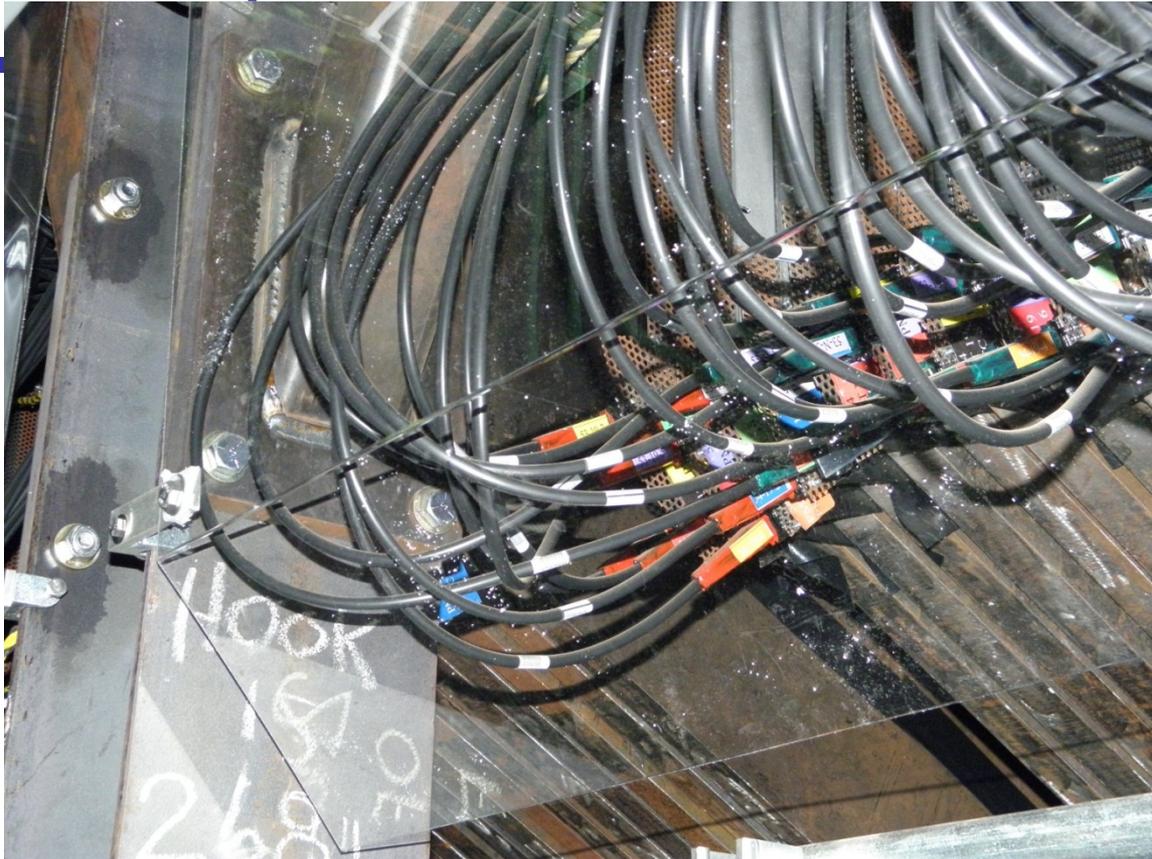
Optical Cable Covers

- Covers prevent people from touching optical cables
 - Sometimes cables aren't properly latched in & come out when touched
- We thank the PPD Mechanical Group for the constructing the rock catcher and cable covers.

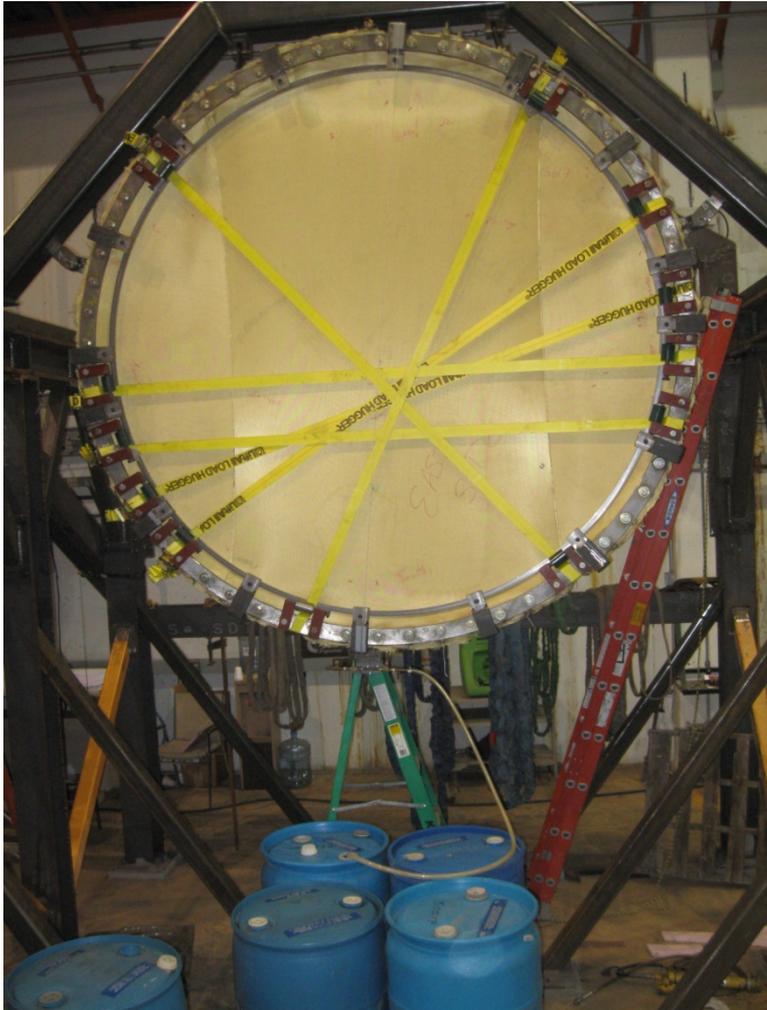
Water Target

- Water target drained
 - If it has a certain life time, we do not want to use it when there is no beam
- But before drained, we had Alignment & Metrology measure what they could
 - Measure the width of the target at the widest extent
 - Measure width from the widest extent to the bottom of the target at 5 points
 - These results will be an input to the calculation of the target shape

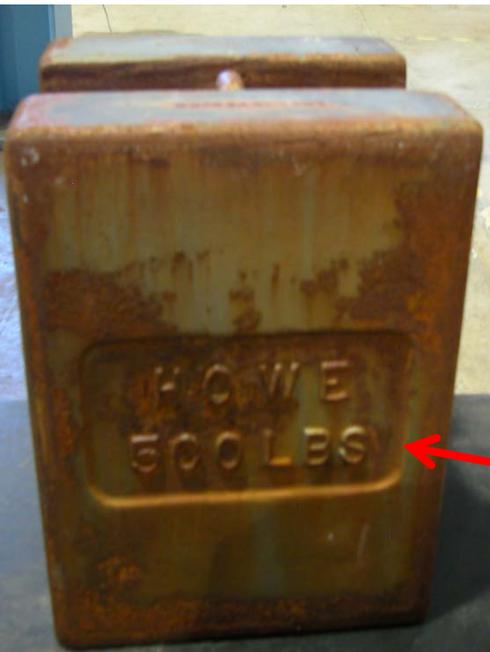
Where did the 40 gallons go ?

- Put 180.1 gal of water in the target on 11/18
 - The 180 gal is close to the calculated volume of the target
 - An additional 12 gallons added as the target expanded
- Removed 148.7 gal of water
 - We think the flow meter for removing the water was not calibrated correctly
- John Voirin suggested we refill the target and weight the 55 gallon drums before and after they have been emptied.
 - Scale has calibrated with 500 lb weight
 - Scheduled to fill target tomorrow
